# 柴油加氢循环 20 碳钢管道脆性爆裂原因

**摘 要:**某化工厂柴油加氢循环 20 碳钢管道发生脆性爆裂。对该管道残片分别进行去应力退火处理和去氢处理,通过与未处理原始状态残片的显微组织和力学性能进行对比,并结合化学成分检测和断口形貌观察等方法对管道爆裂原因进行了分析。结果表明:管道材料在长时间服役后发生应变时效脆化,导致管道脆性爆裂;管道材料的氮元素含量相对偏高,且晶粒出现较大的变形,是发生应变时效脆化的主要原因。

## Brittle Bursting Cause of 20 Carbon Steel Pipe of Diesel Hydrogenation Recycling

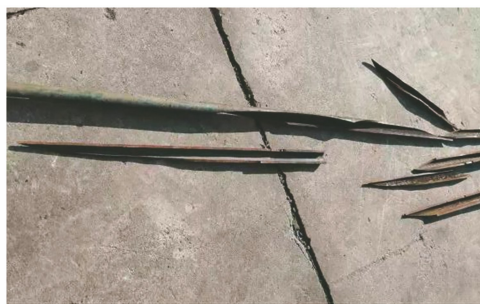
该柴油加氢循环管道为竖直安装,管道整段发生爆裂,形成的残片形貌如图 1 所示。可见:爆裂管

图 1 管道爆裂后的残片形貌

道无明显变形,纵向断口居多,断口整齐;碎片大多沿管道轴向断裂形成,未发生明显变形,呈脆断特征;管道内壁未见明显蚀坑,未出现明显减薄现象。

20 碳钢应具有良好的韧性,但从宏观断裂形貌来看管道发生了脆性断裂,这表明其材料 20 碳钢在使用过程中发生了脆化劣化。取 2 块残片在 TNX1100-30 型马弗炉中进行不同热处理,通过与未热处理残片(原始状态残片)的组织 and 力学性能进行对比来分析材料脆化劣化原因。其中:一块残片进行去应力退火处理,在 600 °C 保温 2 h,随炉冷却,记为去应力退火残片;另一块残片进行去氢处理,在 250 °C 保温 2 h,随炉冷却,记为去氢处理残片。

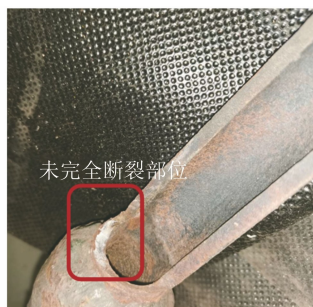
由图 3 可知,爆裂管道的端部并未完全断裂。人为将未断裂部位断开,在爆裂形成的断口(原始断口)和人为形成的断口(人工断口)上取样,采用 S-3400N 型扫描电镜(SEM)观察断口微观形貌。由图 4 可见:原始断口形成后在空气中暴露了一段时间,发生了一定程度的氧化,但仍能观察到一定的解理开裂特征,存在一定的台阶状形貌,与人工断口相似;人工断口未发生氧化,存在清晰的解理面台阶。2 个断口的微观形貌都说明爆裂管道材料发生了脆化。

图 3 爆裂管道端部断裂宏观形貌
