825合金在含单质硫高温高酸性环境中的局部腐蚀行为

摘要: 在132 °C、H₂S分压4.8 MPa、CO₂分压1.6 MPa、氯离子质量浓度42 750 mg·L⁻¹的气田模拟地层水中,通过腐蚀挂片试验研究了825合金在含单质硫(每升地层水中包裹合金的单质硫质量为10 g)与不含单质硫条件下的局部腐蚀行为。结果表明:在不含单质硫条件下825合金几乎不发生腐蚀,腐蚀6 d时的腐蚀速率仅为0.007 7 mm·a⁻¹;添加单质硫腐蚀3 d时腐蚀速率达到0.055 2 mm·a⁻¹,合金发生了严重的局部腐蚀,随腐蚀时间的延长,合金表面局部腐蚀坑面积、腐蚀坑最大深度和腐蚀速率增大。在不含单质硫条件下合金表面腐蚀产物极少,主要为FeCO₃,在含单质硫条件下,随着腐蚀时间的延长,表面腐蚀产物增多,主要为FeCO₃与FeS;单质硫在高温下发生歧化反应产生H⁺和S²⁻,使825合金表面腐蚀产物膜破裂,从而加剧了局部腐蚀。

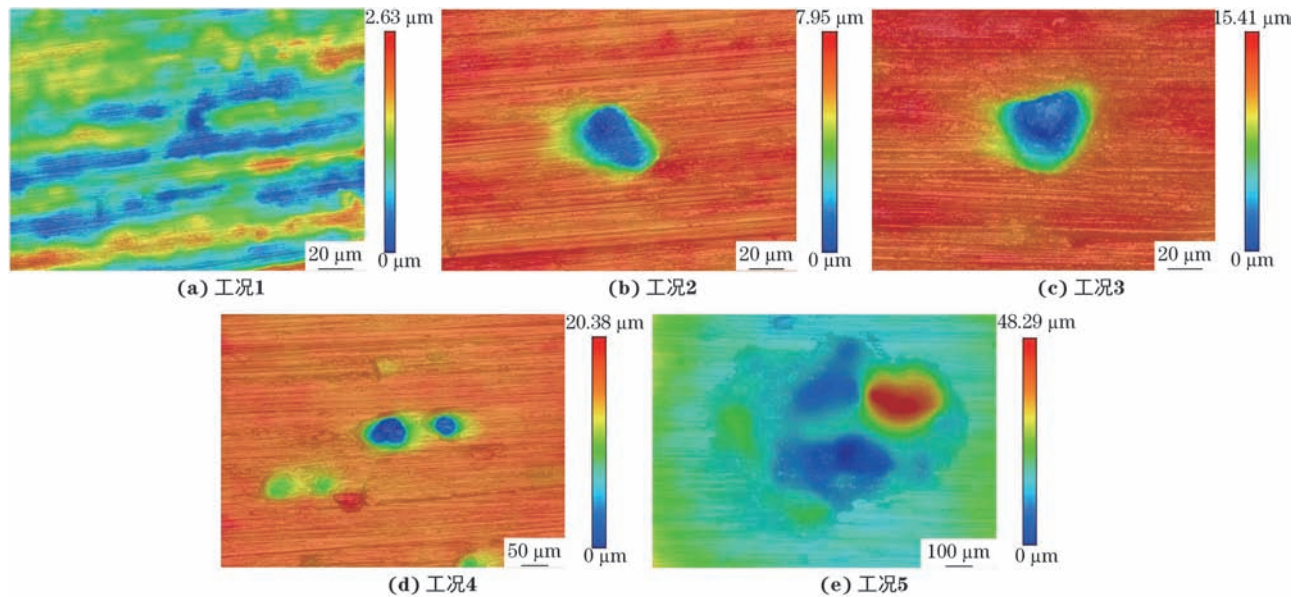
图 2 不同工况下 825 合金的局部腐蚀形貌

Fig. 2 Local corrosion morphology of 825 alloy under different conditions: (a) condition 1; (b) condition 2; (3) condition 3; (d) condition 4 and (e) condition 5

由图2可知:在未添加单质硫腐蚀6 d时,825合金表面较平整,腐蚀痕迹轻微;添加单质硫后,随着腐蚀时间由3 d延长至12 d,合金表面的局部腐蚀坑最大深度由7.95 μm增大到48.29 μm,并且局部腐蚀坑的面积也增大。与未添加单质硫腐蚀6 d条件下(局部腐蚀最大深度2.63 μm)相比,添加单质硫腐蚀6 d时合金的局部腐蚀坑最大深度增加到15.41 μm,局部腐蚀程度加重。
